# TECHNICAL NOTE

D-125

By R. A. Signorelli, J. R. Johnston, and J. W. Weeton

THERMAL-STRESS FATIGUE CRACKING OF TURBINE BUCKETS OPERATED  
AT 1700° F IN A TURBOJET ENGINE WITH  
FREQUENT STARTS AND STOPS

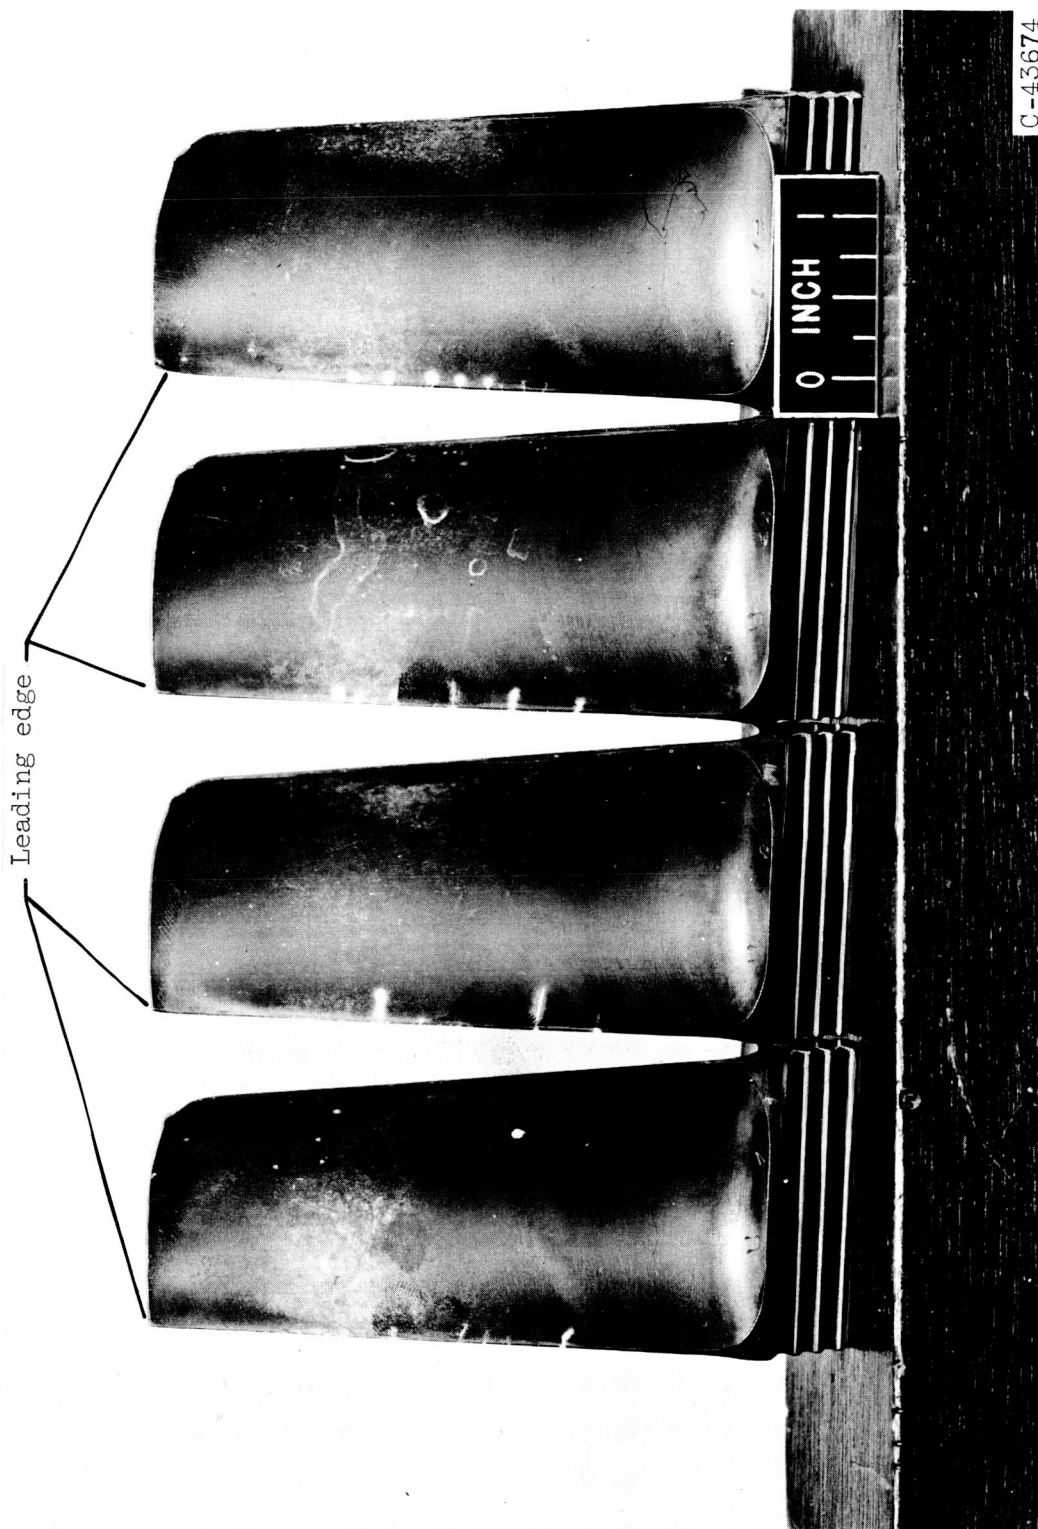
During the total time of the engine test (70 hr), only one bucket fractured. However, large numbers of buckets failed by thermal-stress fatigue cracking. Typical cracked buckets shown in figure 4 are similar to those observed in previous investigations (refs. 3 to 5) with a multiplicity of cracks over a considerable portion of the leading edge. Bucket failure data are presented in figure 5, plotted against starts and stops rather than against time, since this was the primary cause of thermal-fatigue cracking, as was cited earlier from reference 5. Hence, in figure 5, the position of each data point indicates the number of start-stop cycles at which cracks were first observed in each bucket. A time scale, although nonlinear, is shown also, for convenience. Cracking began after relatively few starts. Buckets of cast Udimet 500 and SEL-1 cracked after 10 starts ( $6\frac{1}{2}$  hr at rated speed), Inconel 713 after 12 starts (10 hr), and B and B and forged Udimet 500 after 28 starts (30 hr). The number of buckets with cracks increased at a relatively rapid rate after the first bucket cracked. The numbers of starts to crack 50 percent of the buckets (i.e., the median life) of each alloy group as indicated by the arrows in figure 5 are as follows: 24 for cast Udimet 500, 28 for Inconel 713, 29 for SEL-1, 36 for forged Udimet, and 45 for B and B. The median life of the B and B alloy buckets, the most crack-resistant group, is almost double that for cast Udimet 500, the least crack-resistant group. However, by the end of the test, 70 hours at rated speed and 49 starts, 60 to 90 percent of the buckets in each alloy group were cracked, as may be seen in figure 5.

Figure 4. - Typical thermal-fatigue cracked buckets.

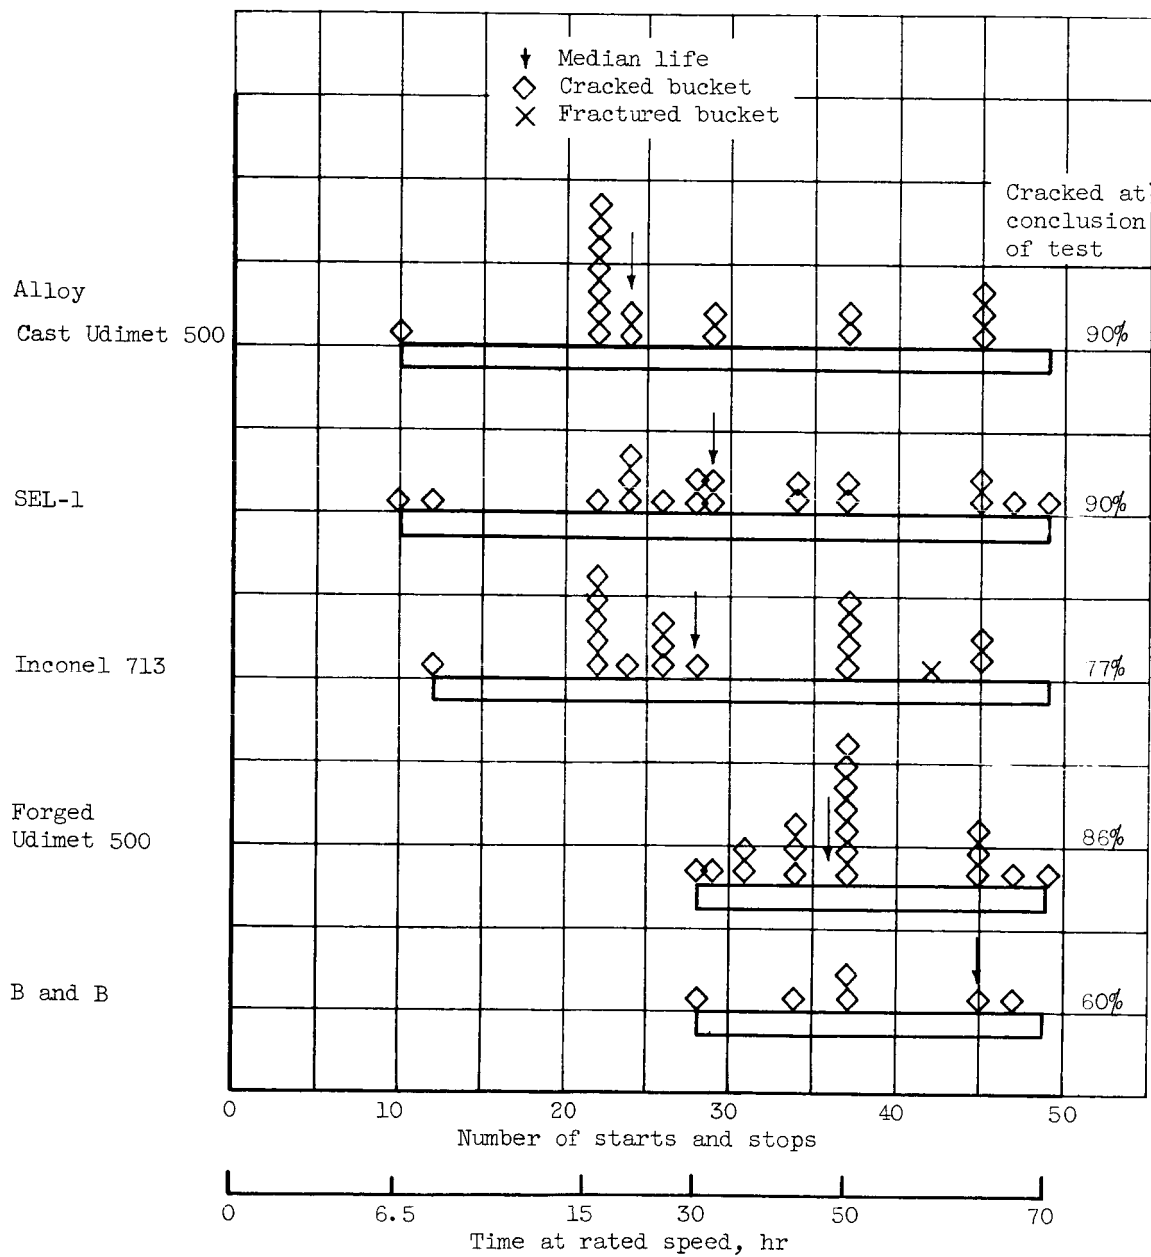
Figure 5. - Engine performance of turbine buckets operated at 1700° F.
